The Space Shuttle Columbia: A Materials Forensic Analysis

MICROSCOPY 2007

Steve McDanel
Failure Analysis and Materials Evaluation Branch
NASA
Kennedy Space Center, Florida

Shuttle Columbia: STS-107

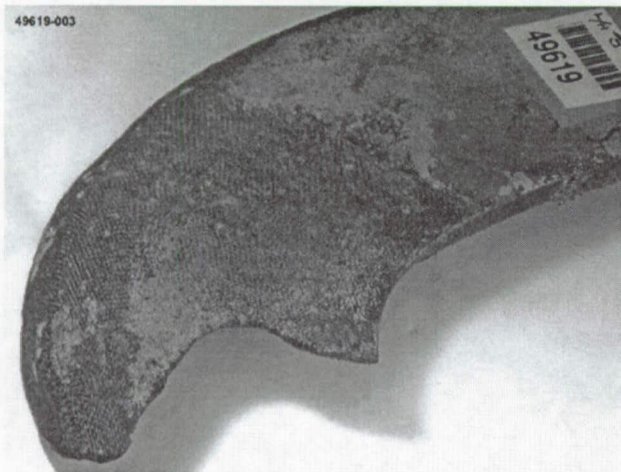
Erosion on Panel 8 Upper Outboard Rib

Outboard
apex

Rib tapers from
design thickness of
.365" to .05".
